75 Years Later, Mount Rushmore Is Still an Engineering Marvel

Many of the mechanics that went into creating such a colossal sculpture are still being used today.

BY LAURA KINIRY OCT 31, 2016

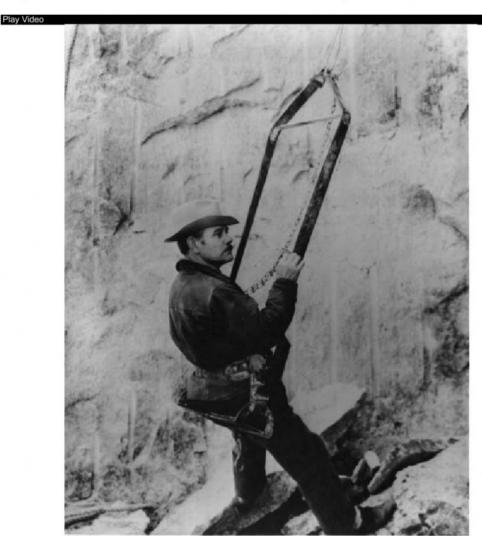
Gutzon Borglum on a Bosun chair inspecting Mount Rushmore. U.S. NATIONAL PARK SERVICE

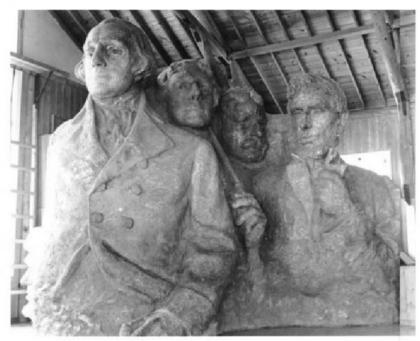
Final plaster model of Mount Rushmore used as reference to finish the massive sculpture.

One method in particular—the pointing system—dates as far back as the ancient Greeks and Egyptians. Borglum and his team used this three-point method to help achieve Mount Rushmore's lifelike appearance. Basically, an inch on Rushmore's scale model equalled a foot on the sculpture, so workers simply multiplied everything by 12. They then used a disk marked off in degrees like a protractor with a horizontal beam sticking out from its central axis. They'd position the disk at the top of a president's head, and from it the pivoting beam would measure the horizontal distance to the point Borglum and his workers were looking to pinpoint. From that beam they'd drop down **a plumb bob** to measure the vertical distance.

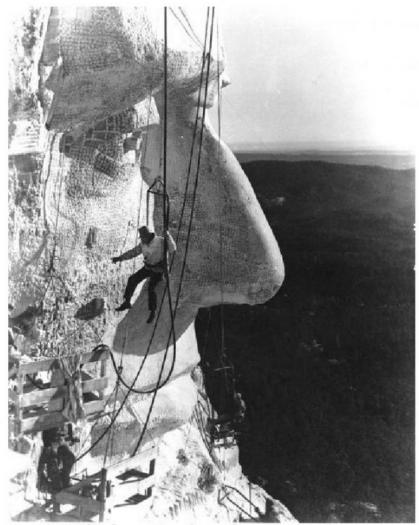
Abraham Lincoln under construction.
