## The Brooklyn Bridge

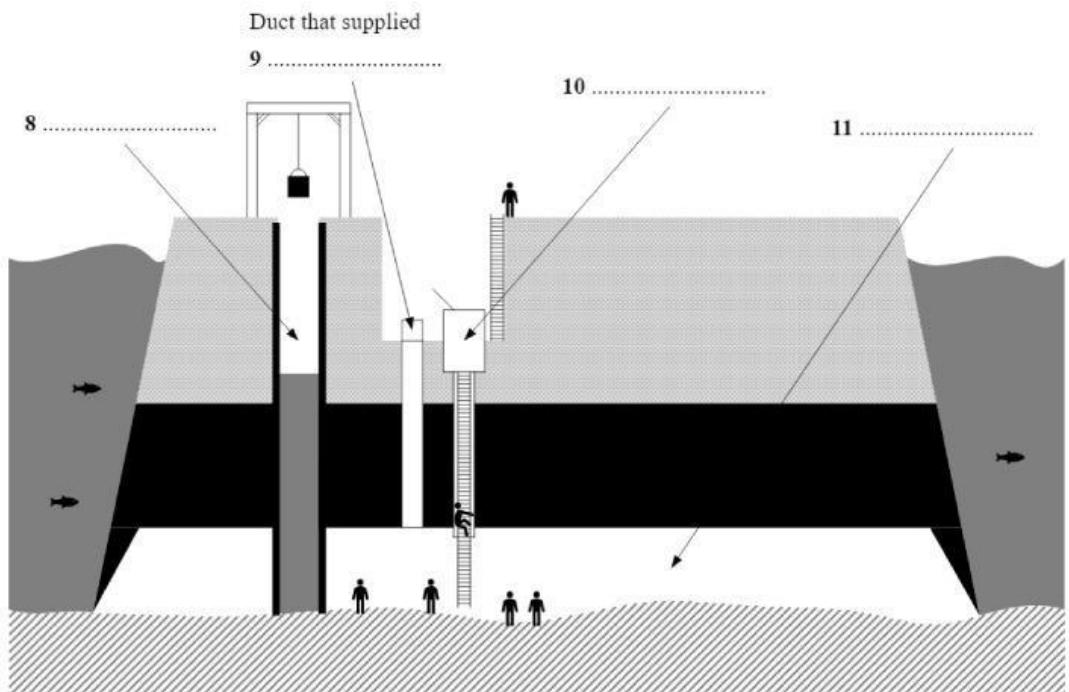
## Brooklyn Bridge caisson

Construction of the Brooklyn Bridge began in January 1870. In order to dig solid foundations for the bridge's stone towers, massive wooden boxes with no bottoms called caissons were used. The caissons allowed workers to dig away at the sand and rock on the riverbed without being flooded by the river water. The stone towers were built on top of the caissons, which sank deeper into the riverbed as the workers dug. Water was kept out of the chamber at the base of the caisson where the workers dug by means of compressed air, which was pumped in through a special duct in the roof of the caisson. Workers entered via a series of ladders, passing through an air lock on the way

down. This had a door on each side, only one of which could be opened at any one time. Had both doors been opened, compressed air would have escaped, with dire consequences for the workers. The sand, rock and boulders that workers excavated were hoisted out of the caisson in huge buckets via a shaft. This was filled with water in order to maintain the correct air pressure. When the caissons had reached the desired depth, concrete was pumped into them until they formed solid blocks. These then became part of the permanent foundations.
